PKCT Community Consultative Committee Meeting 18th March 2020

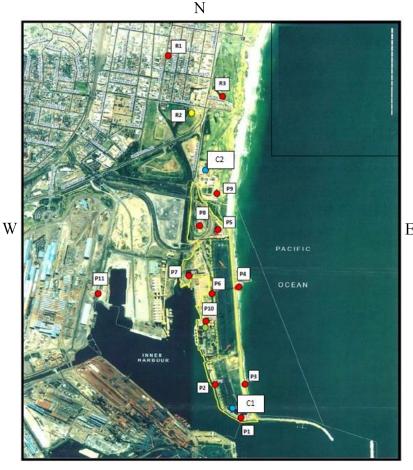
PORT KEMBLA COAL TERMINAL DUST & WEATHER MONITOR LOCATIONS

EPL No.	PKCT No.	Dust Monitor Location Description
1	P1	25m south of Bulk Products Berth (BPB)
2	P2	40m south of Bulk Products Berth stockyard
3	P3	40m east of Bulk Products Berth stockyard
4	P4	40m east Coal Berth stockyard
5	P5	Northern Pond (Pond No.1)
6	P6	40m west Coal Berth stockyard
7	P7	250m west of Coal Berth stockyard
8	P8	PKCT north truckwash
9	P9	Wollongong Wastewater Treatment Plant
15	P10	North of PKCT Planning Office
17	P11	Entry Gate to BlueScope Ro Ro (Berth 109)
12	R1	157 Church Street (two gauges)
19	R2	Vikings Oval, Wollongong (two gauges)
TBA	R3	Links Seaside Apartments
20	C1	Continuous Dust Monitor 1
21	C2	Continuous Dust Monitor 2

refer PKCT Environment Protection Licence(EPL) No. 1625 (EPA ID No.) Dust Gauges- Environment Protection Licence monitoring sites Sites denoted "P": industrial; "R": residential
