**PKCT Community
Consultative Committee Meeting
June 2020
Remote delivered for COVID-19**

*PKCT: A valued link in the
global coal supply chain*

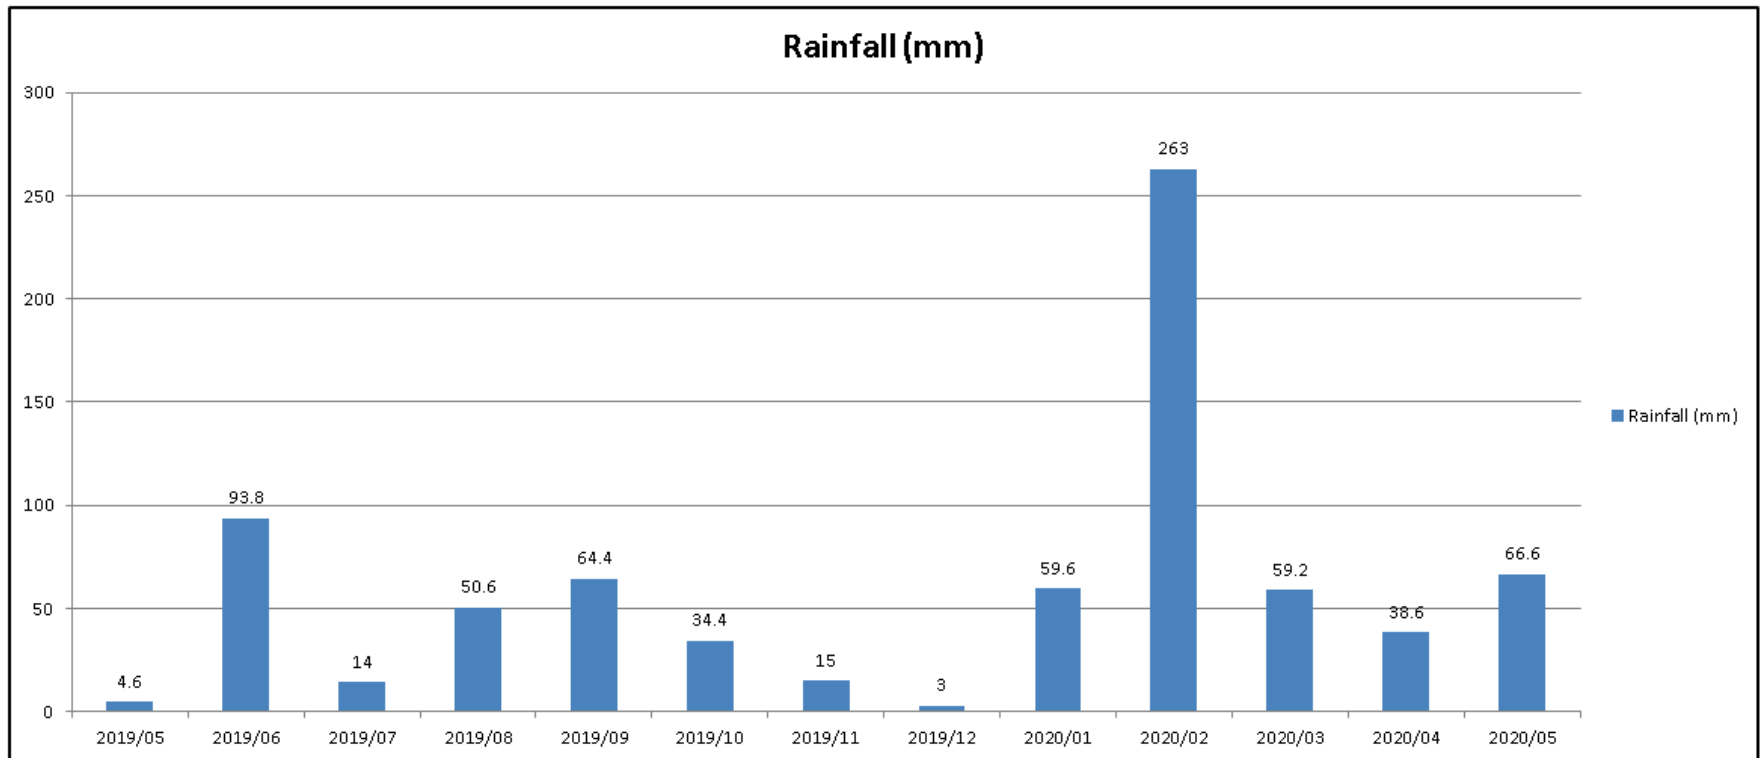
Rainfall

- Last significant rainfall February 2020, 263mm across month

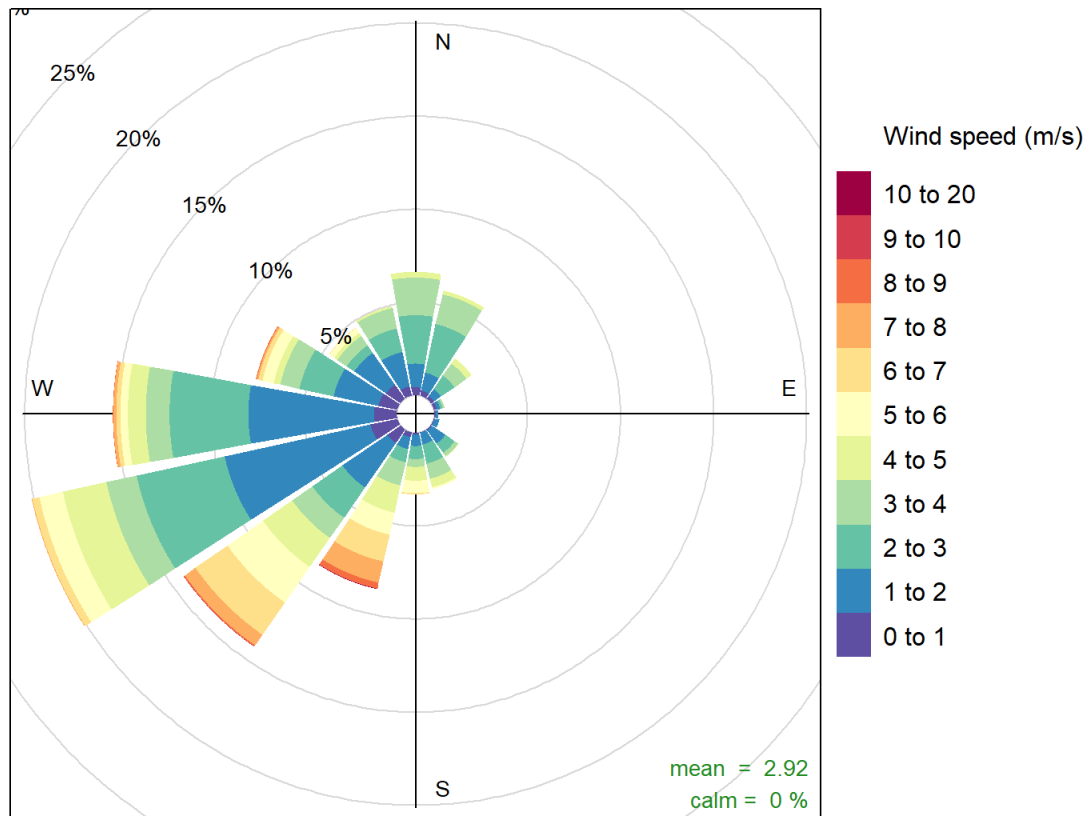
Wind – May 2020

Northern monitor

Frequency of counts by wind direction (%)

- Wind results measured at Northern dust gauge at SWTP May 2020.
- Mixture of wind directions. Most and strongest from the South West followed by West
- 1m/sec = 3.6km/h

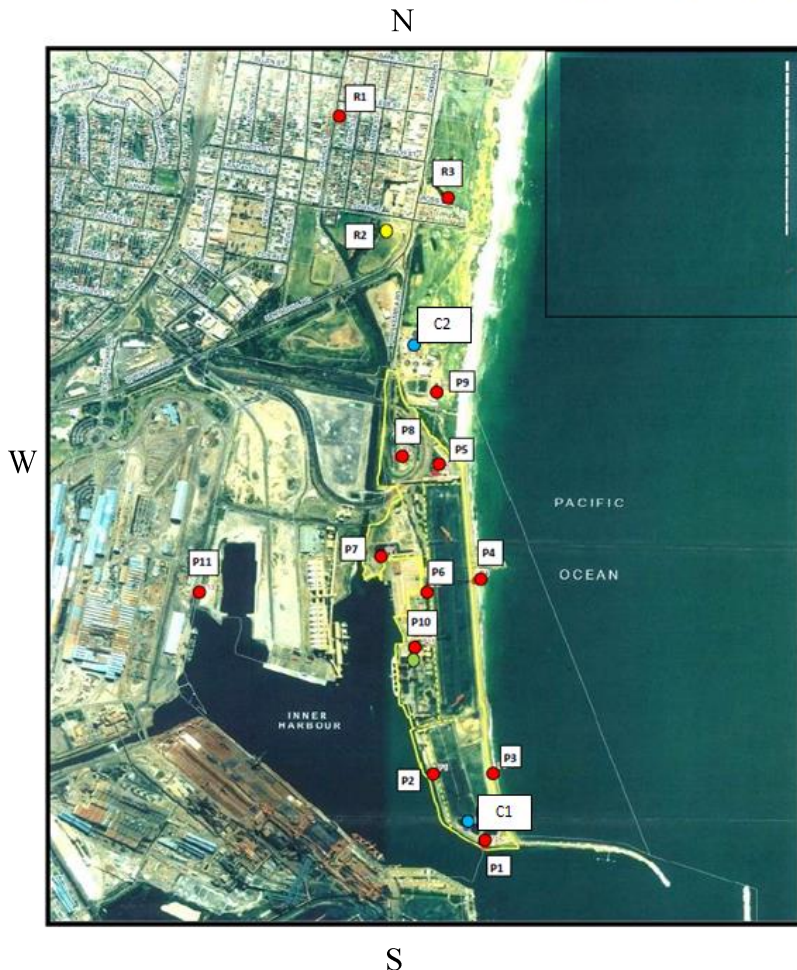
Dust Gauge Locations

PORT KEMBLA COAL TERMINAL DUST & WEATHER MONITOR LOCATIONS

EPL No.	PKCT No.	Dust Monitor Location Description
1	P1	25m south of Bulk Products Berth (BPB)
2	P2	40m south of Bulk Products Berth stockyard
3	P3	40m east of Bulk Products Berth stockyard
4	P4	40m east Coal Berth stockyard
5	P5	Northern Pond (Pond No.1)
6	P6	40m west Coal Berth stockyard
7	P7	250m west of Coal Berth stockyard
8	P8	PKCT north truckwash
9	P9	Wollongong Wastewater Treatment Plant
15	P10	North of PKCT Planning Office
17	P11	Entry Gate to BlueScope Ro Ro (Berth 109)
12	R1	157 Church Street (two gauges)
19	R2	Vikings Oval, Wollongong (two gauges)
TBA	R3	Links Seaside Apartments
20	C1	Continuous Dust Monitor 1
21	C2	Continuous Dust Monitor 2

- # refer PKCT Environment Protection Licence(EPL) No. 1625 (EPA ID No.)
- Dust Gauges- Environment Protection Licence monitoring sites
Sites denoted "P": industrial; "R": residential
 - Continuous Dust Monitor Sites- additional
 - (a) BlueScope High Volume Sampler & dust gauge
(b) PKCT EPL Monitoring Site R2 (2 gauges)
 - Weather stations
 - (a) at each continuous dust monitor site ●
 - (b) PKCT Main Control Room ●

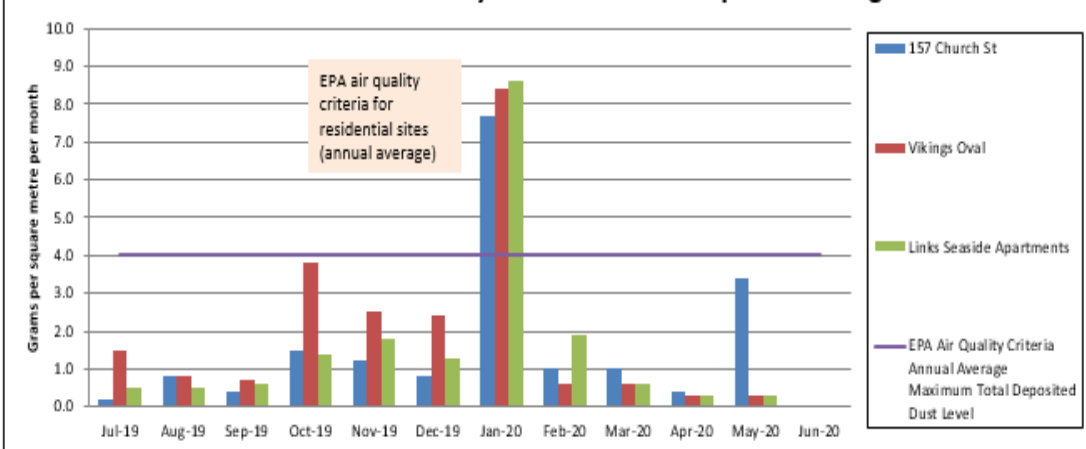
Insoluble Solids - Monthly Residential Dust Deposition Gauges

- Nb criteria below is an annual average. Data presented in graphs to left is monthly actuals.
- Three residential dust gauges were all below EPA 12 month rolling average Air Quality Criteria for Insoluble Solids and Combustible Matter for all months.
- January saw a much higher than normal depositional dust trend for both insolubles and combustible matter. These elevated levels were a result of the prolonged bushfire smoke haze and drought conditions across the region. High combustible matter recorded at the Vikings Oval gauge in October was confirmed by the lab as insect remains.
- 12 month rolling average Insoluble Solids*
 - Ross St (Links) – 1.6 g/m² month
 - Church St – 1.6 g/m² month
 - Vikings Oval – 1.9 g/m² month
- 12 month rolling average Combustible Matter*
 - Ross St (Links) – 0.4 g/m² month
 - Church St – 0.3 g/m² month
 - Vikings Oval – 0.8 g/m² month

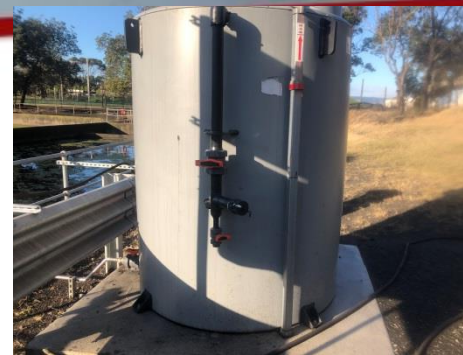
Completion of North pond Coagulant Dosing System

A fully automated coagulant dosing system has been installed and commissioned at the north pond to improve PKCT's water treatment capabilities. >\$30,000, The dosing plant complements the existing system in the Central Pond and over the past few months has been effective in removing clays from the water

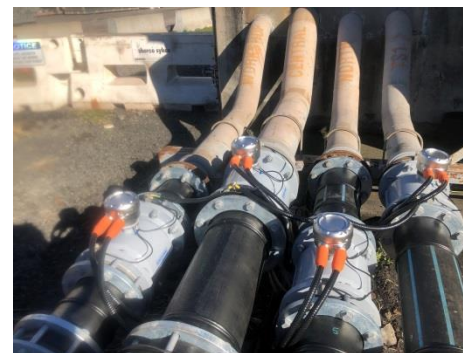
Flow Meters

Four magna-flow flow meters have been installed at the Settlement Lagoon. Cost of >\$30,000, the meters will allow PKCT to monitor pump condition, set flow rates and quickly identify system failures once fully commissioned.

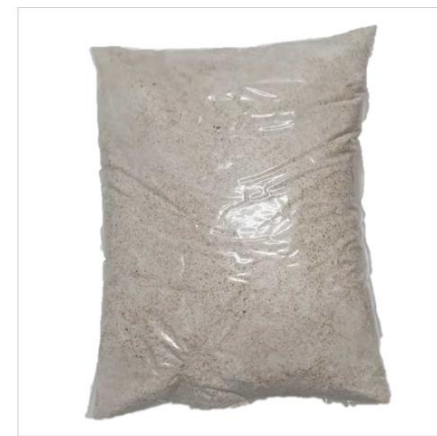
Biostim Trial

PKCT has had problems with algal blooms in one of our ponds since the introduction of recycled water in 2009. Elevated algal counts have the potential to add TSS to our discharge water and in high levels potentially exceed our licence conditions. PKCT has engaged a specialist to assist in this space and is currently undertaking a trial in our Settlement Lagoon of an algal control product called Biostim. If successful, the natural, non-toxic product will assist with reducing the extent and frequency of algal blooms in our lagoon and reduce the likelihood of an EPL exceedance as a result.
