PORT KEMBLA COAL TERMINAL LTD.

PORT KEMBLA COAL TERMINAL DUST & WEATHER MONITOR LOCATIONS

SETTLEMENT LAGOON OVERFLOW: ENVIRONMENT PROTECTION LICENCE MONITORING: Licenced Discharge POINT 16						
Environment Protection Licence: 1625 Type of Monitoring: water quality Frequency: daily grab sample when discharging			water quality parameter		EPL Limit (100 percentile)	
			pH		monitoring only	
			total suspended solids (mg/L)		less than 50	
			oil/ grease (milligrams per litre)		not visible	
Sample Date	Date Results Obtained	Date Published	pH (pH units)	total suspended solids (milligrams per litre)	oil/ grease (milligrams per litre)	Commentary on Results
17/01/2020	24/02/2020	26/02/2020	8.8	62	not visible	TSS marginally exceeded EPL limit. Two samples were taken and the second sample recorded TSS of 59mg/L TSS. Exceedance has been reported to EPA. Action plan has been developed and implementation of the plan is underway.
22/01/2020	24/02/2020	26/02/2020	10.0	20	not visible	EPL compliant
23/01/2020	24/02/2020	26/02/2020	10.0	26	not visible	EPL compliant

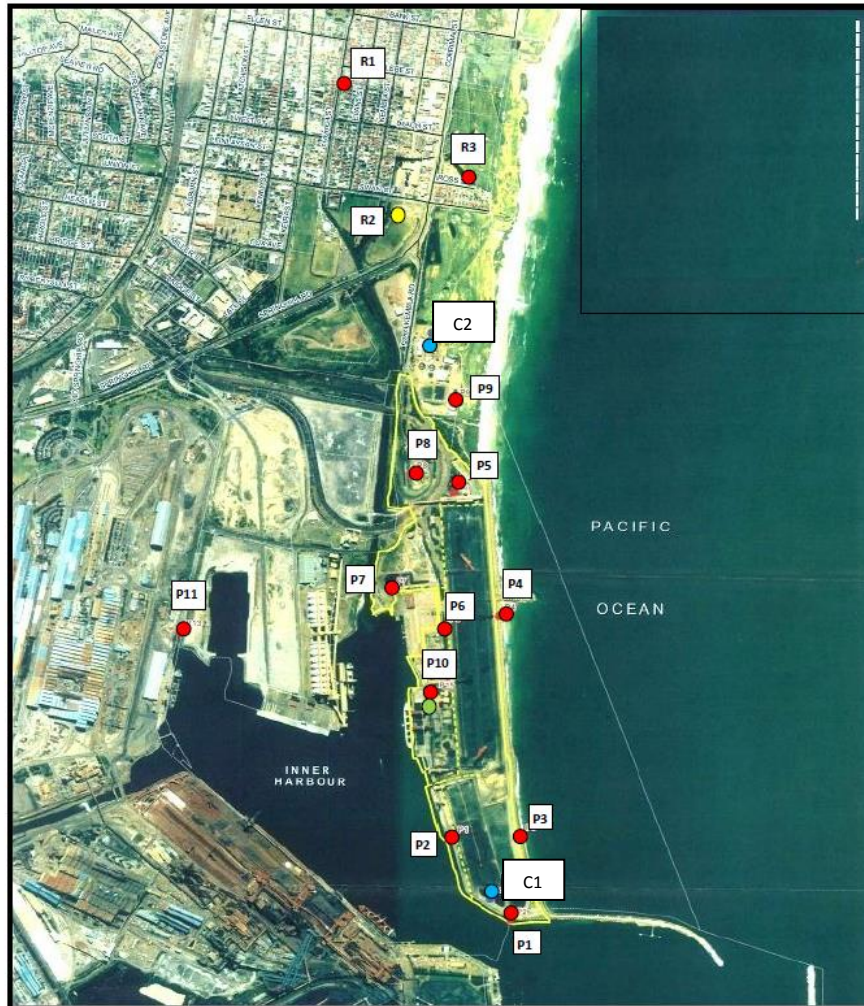
EPL No.	PKCT No.	Dust Monitor Location Description
1	P1	25m south of Bulk Products Berth (BPB)
2	P2	40m south of Bulk Products Berth stockyard
3	P3	40m east of Bulk Products Berth stockyard
4	P4	40m east Coal Berth stockyard
5	P5	Northern Pond (Pond No.1)
6	P6	40m west Coal Berth stockyard
7	P7	250m west of Coal Berth stockyard
8	P8	PKCT north truckwash
9	P9	Wollongong Wastewater Treatment Plant
15	P10	North of PKCT Planning Office
17	P11	Entry Gate to BlueScope Ro Ro (Berth 109)
12	R1	157 Church Street (two gauges)
19	R2	Vikings Oval, Wollongong (two gauges)
TBA	R3	Links Seaside Apartments
20	C1	Continuous Dust Monitor 1
21	C2	Continuous Dust Monitor 2

- # refer PKCT Environment Protection Licence(EPL) No. 1625 (EPA ID No.)
- Dust Gauges- Environment Protection Licence monitoring sites
Sites denoted "P": industrial; "R": residential
- Continuous Dust Monitor Sites- additional
- (a) BlueScope High Volume Sampler & dust gauge
(b) PKCT EPL Monitoring Site R2 (2 gauges)
- Weather stations
- (a) at each continuous dust monitor site ●
- (b) PKCT Main Control Room ●

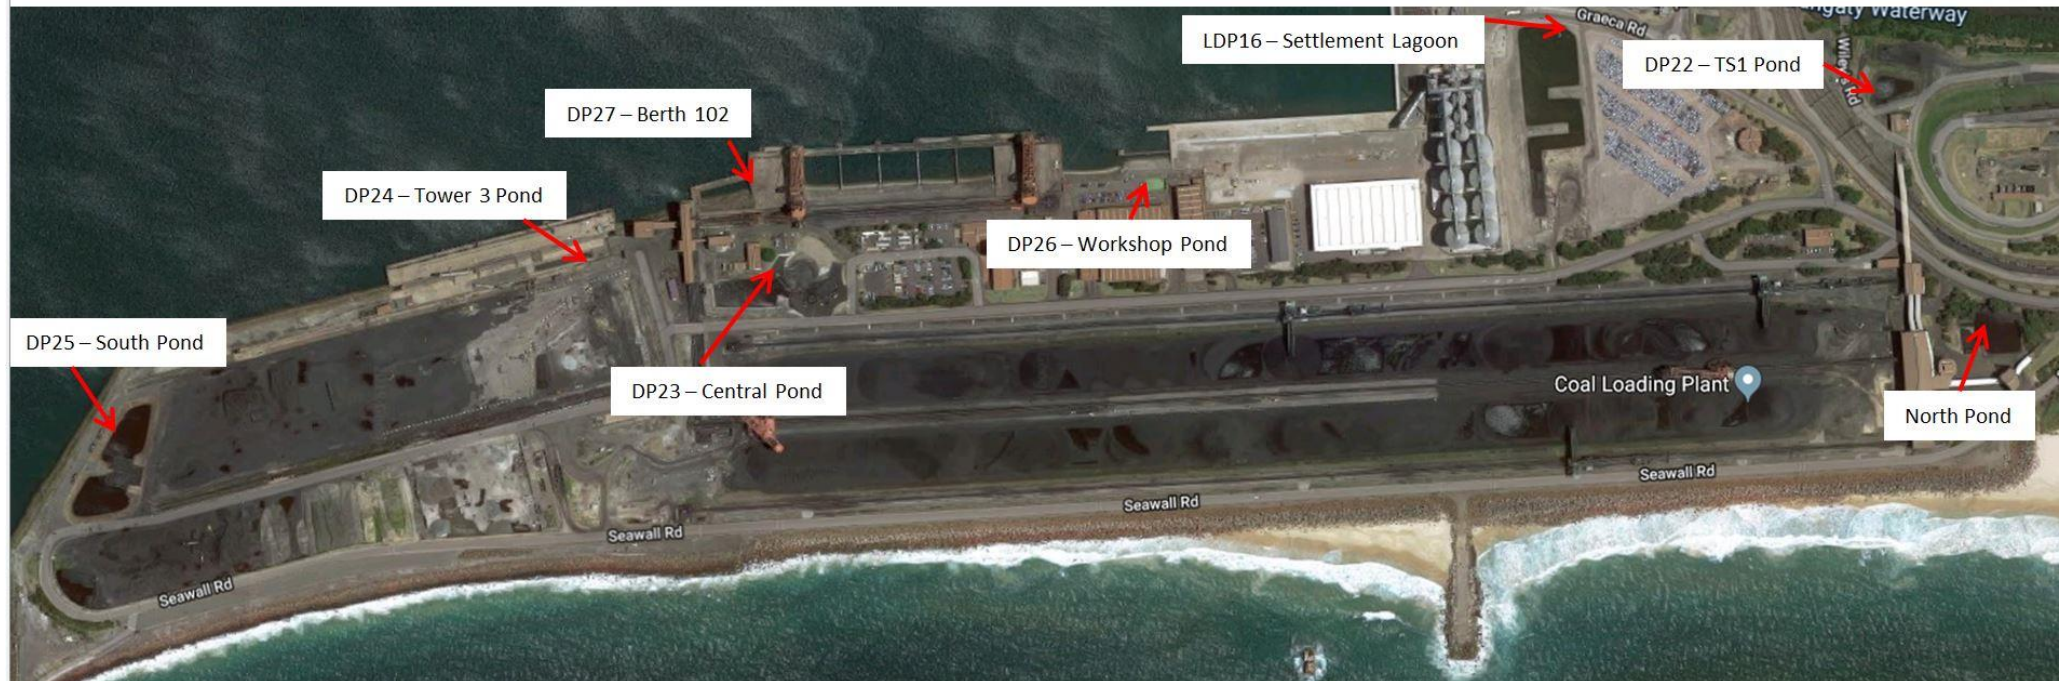
PKCT Water Collection System Discharge Points

Ponds location/names: TS1 pond: DP22, Central Pond: DP23, Tower 3 pond: DP24, South Pond: DP25, Workshop Pond DP26, Berth 102 DP27.
