PKCT Community Consultative Committee Meeting

February 2026

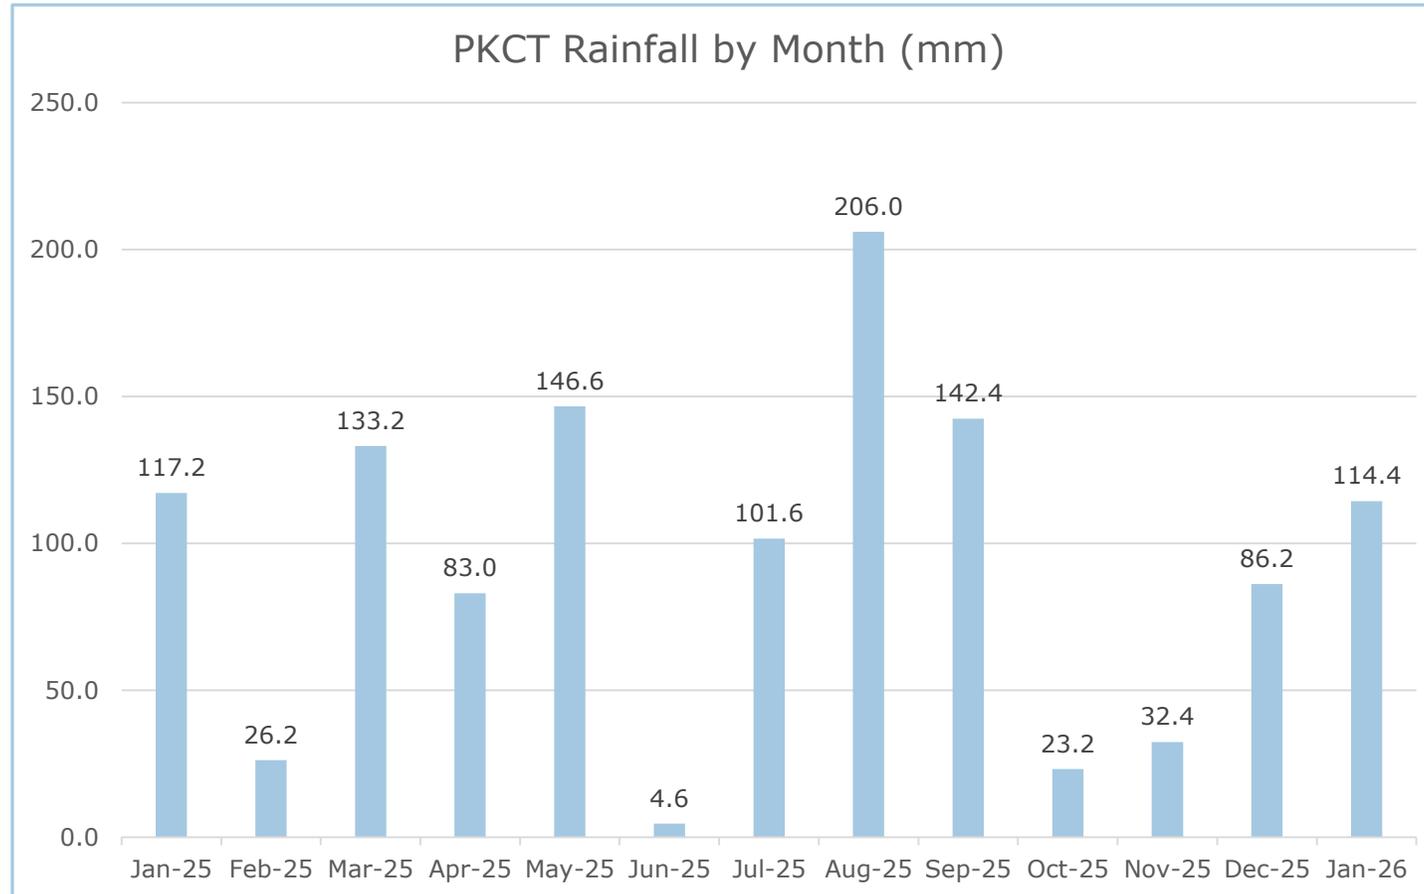
- Last significant rainfall 17/18 January 2026, 89.4mm in 24 hours.

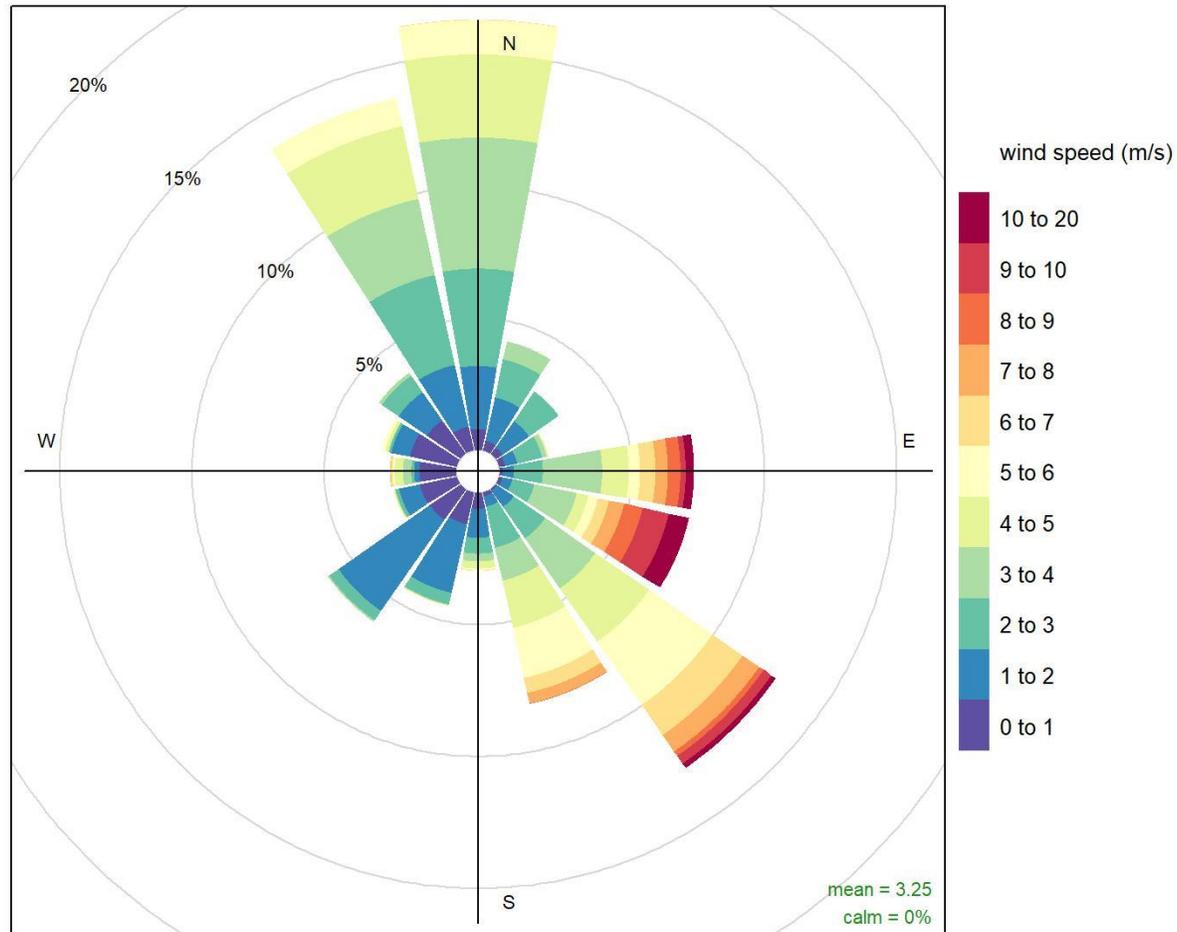
Northern Monitor

- Wind results measured at Northern dust gauge at SWTP Jan 2026.
- Mixture of wind directions. Most from the N/NW and SE quadrants
- m/sec = 3.6km/h

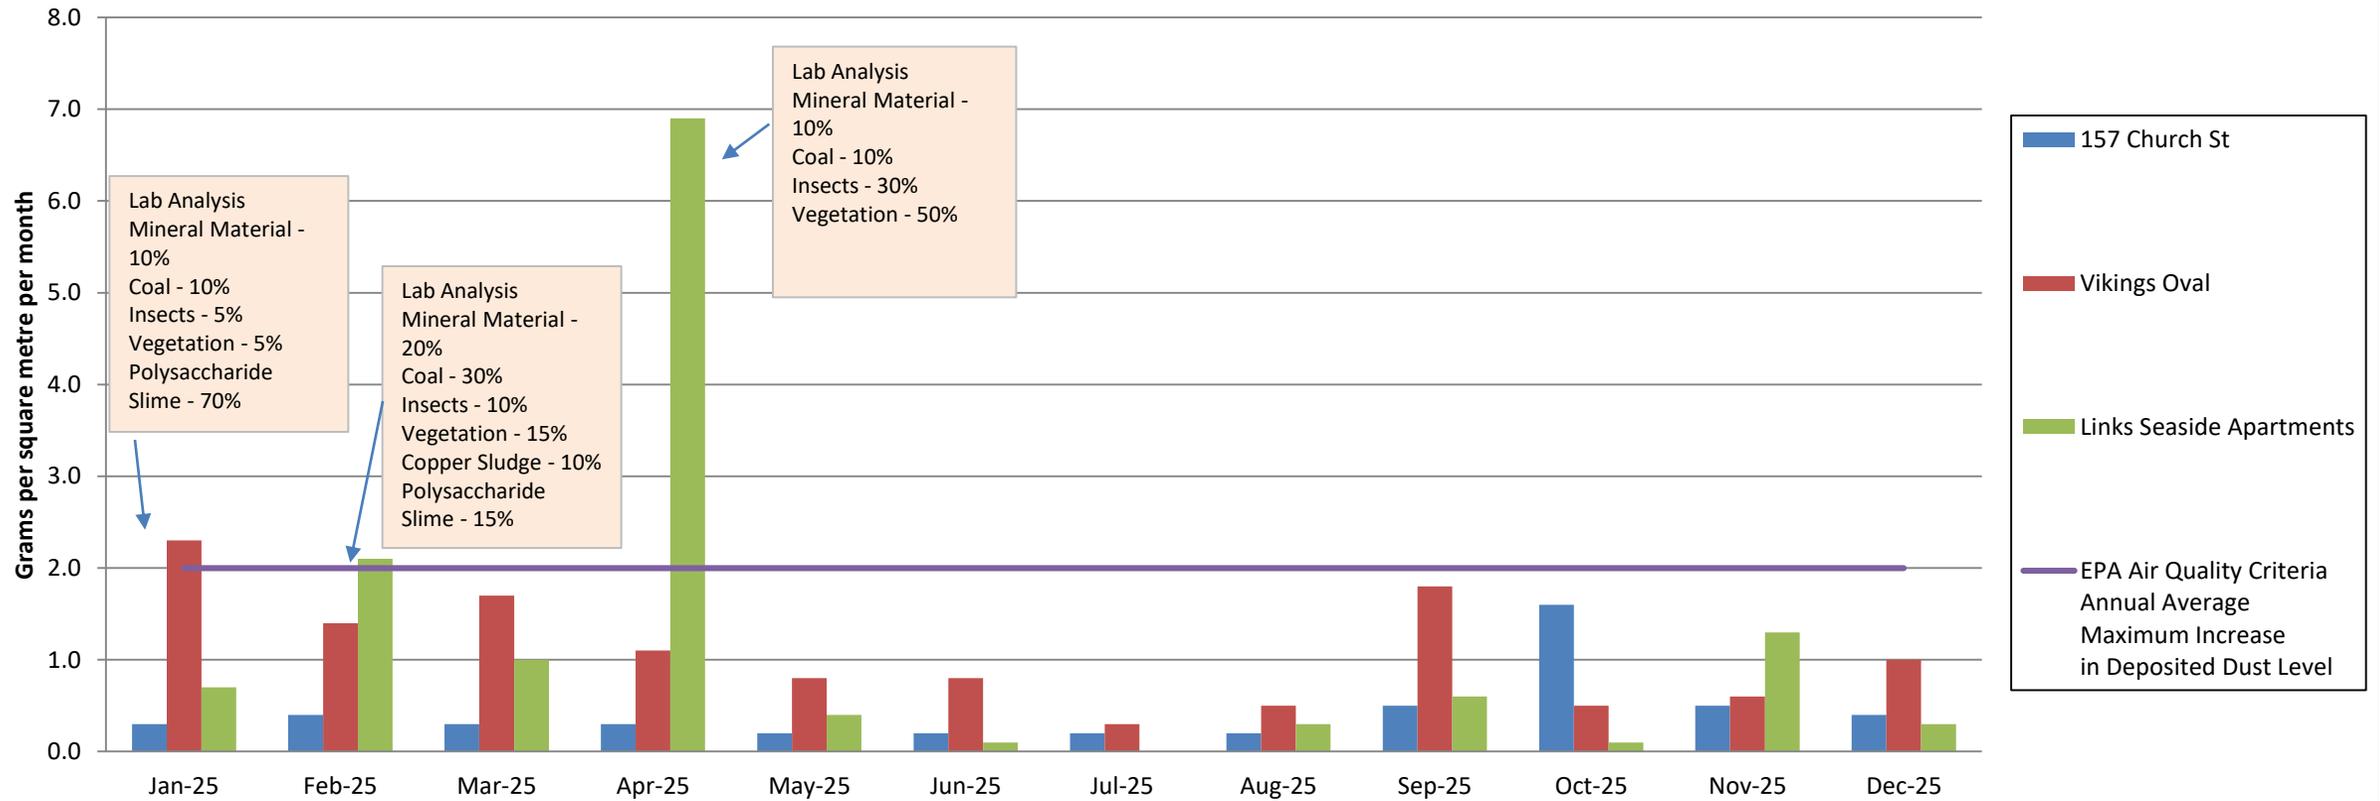
Combustible Matter - Monthly Residential Dust Deposition Gauges

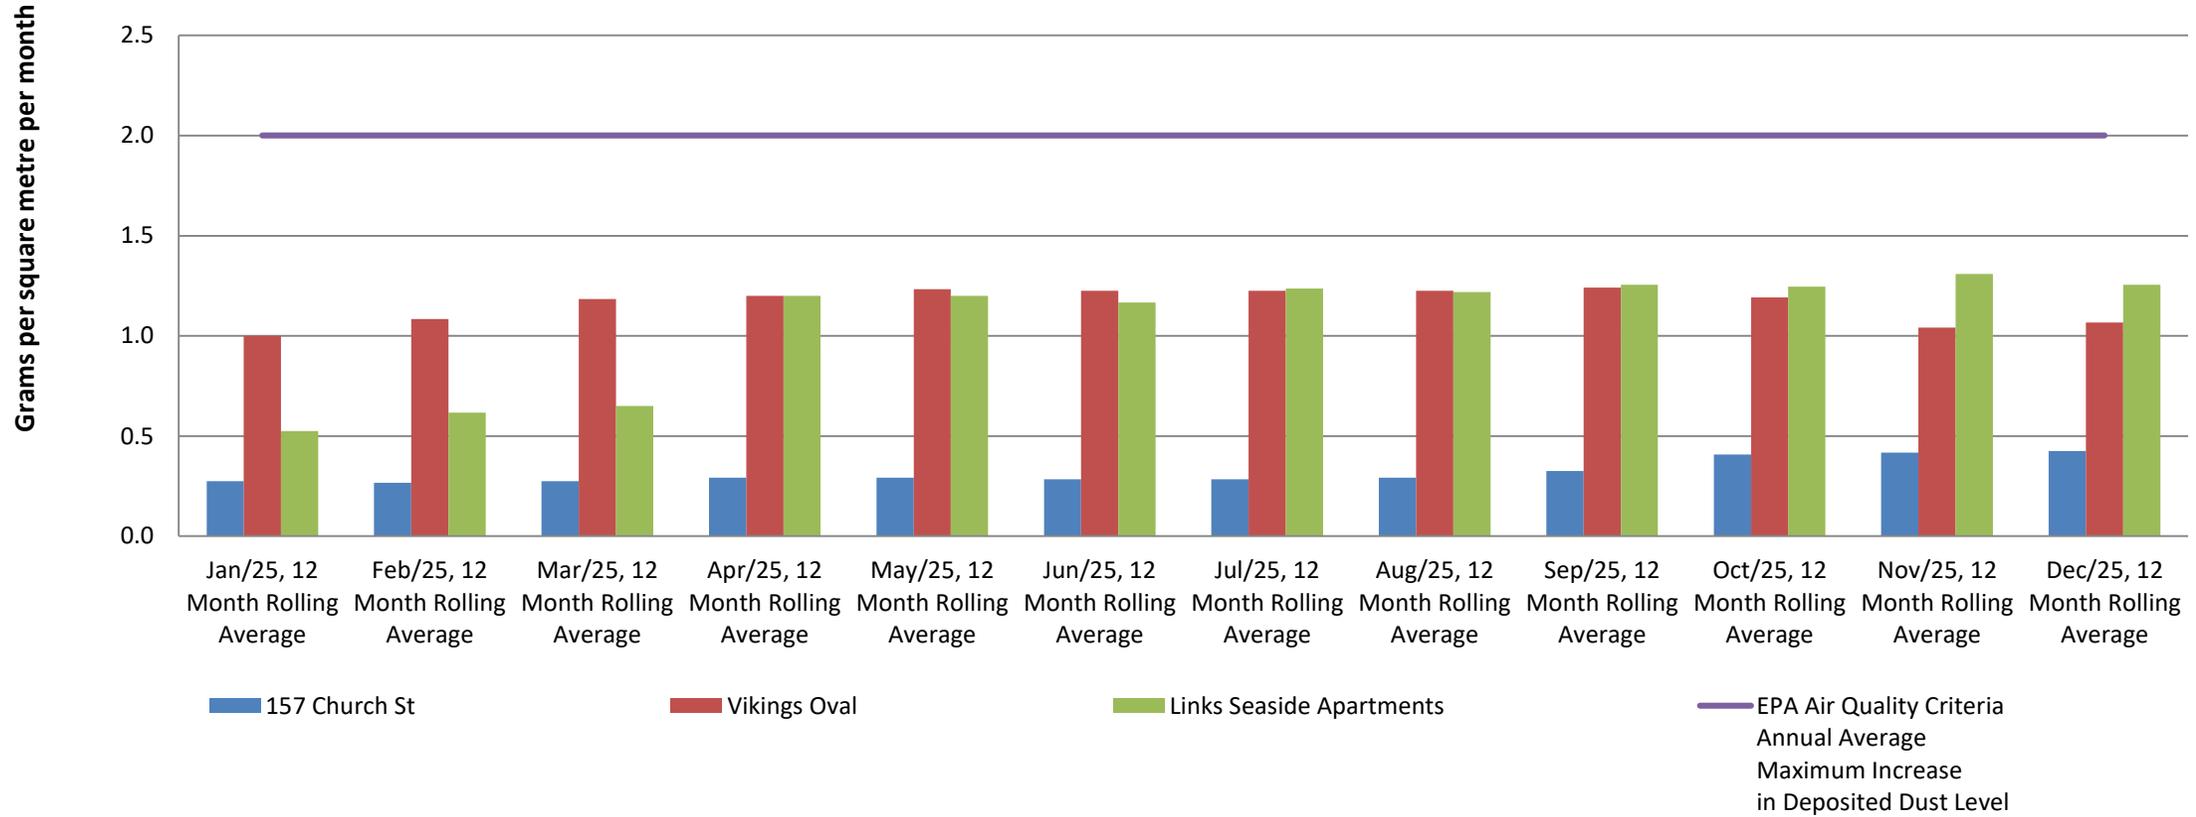
Depositional Dust – Residential 12 month rolling average combustible matter

Combustible Matter - 12 Month Rolling Average Residential Sites

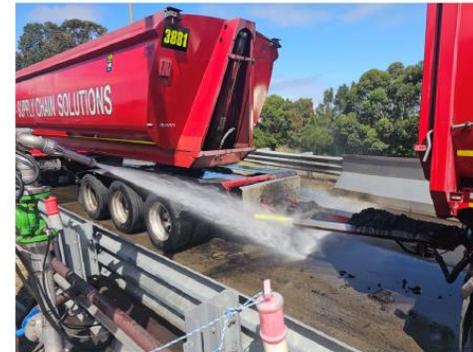
NTW Water Cannon – Reduce drag out onto roadways

Eastern cannon installed; commissioning now at the stage where the water cannon self triggers on trucks and sprays a selected pattern to wash them. Close to full implementation with guarding and other items needing completion.
